A School Through Time

200 years in the life of
Antingham and Southrepps School and its people

Margaret Dowland

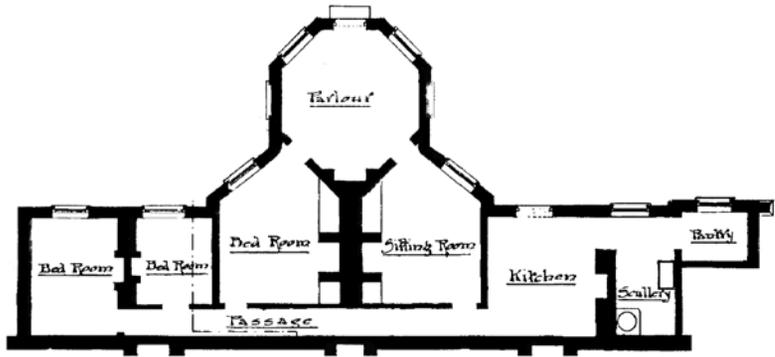
The school house was the home of every Headmaster until 1971. It had three bedrooms, a parlour, sitting room, kitchen, scullery and lobby. It also had a large vaulted cellar, which is inaccessible today. It is believed to have been largely unchanged apart from the conversion of one of the bedrooms to a bathroom. This plan shows how it would have been in 1826.

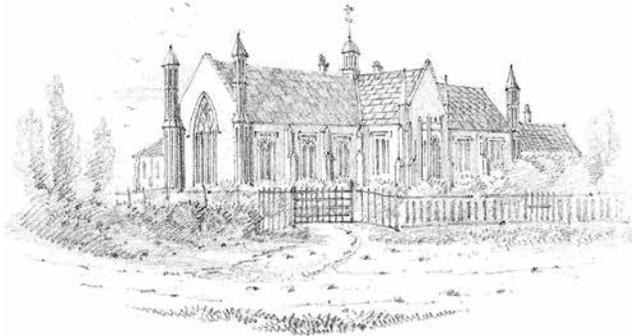
Enlarged image of pen and ink drawing on the 1835 plan. The building to the rear is the school house. There are three windows to the left-hand side of the porch rather than the four that are there today.

What is striking, if one is familiar with the building, is the size of the end window. It also looks very ecclesiastical. This may well be explained by looking at St Margaret's Church in Thorpe Market, c1796. Both buildings were built for Lord Suffield, and it is assumed to be by the same builder, who is believed to be a Mr Wood. Little is known of him except that he is thought to have been involved in the construction of the Pyramid mausoleum at Blickling.

The design is described as Gothic and the materials used are stone and flint. This was a prestigious building, far above a simple flint cottage. Not only are the flints knapped but those on the pinnacles are squared as well; this would have been time consuming and expensive of resources. This suggests that Lord Suffield was sending a message with this school. It has been built to the same high standards as the church; it is perhaps saying this is an important building, education matters. If you look at other buildings in the villages from the same period this one really stands out.

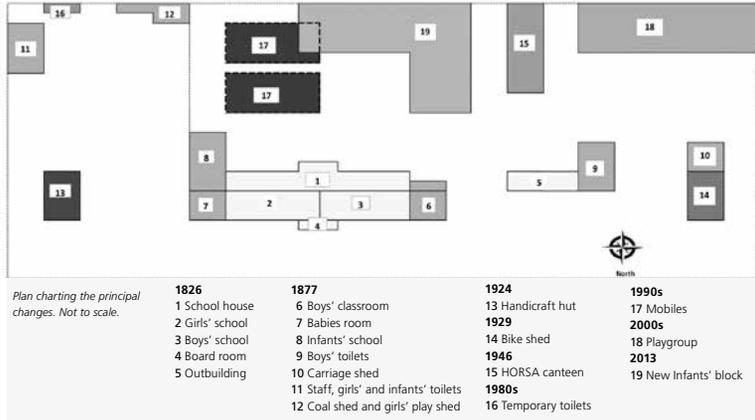
Rear view of the school taken prior to 1877. It shows the school house. Behind is the school and on the left the outbuilding. On the 1835 plan the rear of the school house is all marked as playground. Antingham and Southrepps School.

The original buildings were: the school consisting of two school rooms, the school house, the board room or porch, and an outbuilding.

The school consisted of two large school rooms. There was no internal access between the school and the school house. The outbuilding shown on the old photograph was probably a storehouse.

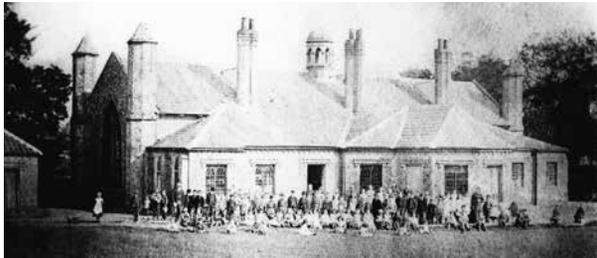
This end of the building was the Boys' school, opening into their playground. The building in the foreground, which is the original outbuilding, was also extended to become the boys' offices, as toilets were known.

Opposite the boys' offices was the stabling for the managers' horses and carriages, for use when attending meetings; it also doubled up as the boys' play shed. When the managers applied for a loan to extend the school they were refused money to build the carriage shed,

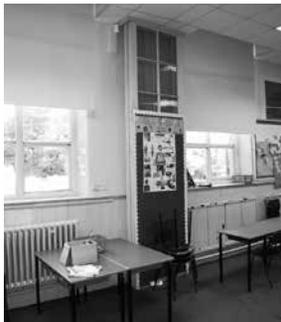
Far left: The carriage shed (number 10 on the plan). In 2002, with money from the Judith Bartram Trust, the carriage shed was converted into a music room for the school. It is also used as a meeting room and a quiet area for small groups to work.

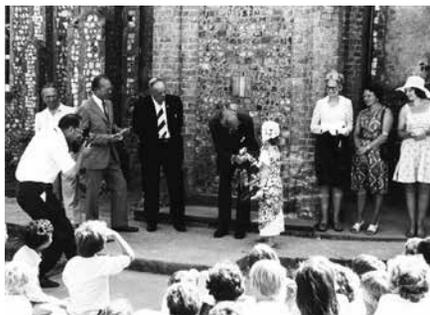
As part of the 150th anniversary celebrations in 1976 the bricked-up doorway was faced with knapped flints with a date inscription above. In 1996 the flints were removed and a door reinstated. The inscription remains. Antingham and Southweps School.

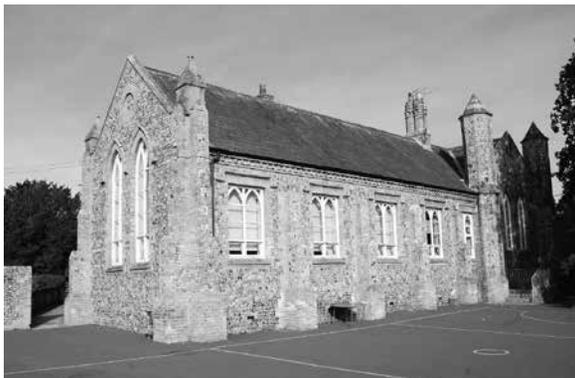
Infants' school (number 8 on the plan). Although the Infants' school was built in the same style its pinnacles are nowhere near as ornate as those on the main part of the building. The buttresses are also different.
